Investigation of a Highway Bridge

# INVESTIGATION OF A HIGHWAY BRIDGE

# An Investigation of the Gilbert St. Bridge

The Gilbert St. Bridge, as it is locally called, is a long highway bridge spanning the Vermilion river, and is located about one-half mile west from the business district of the City of Danville, Illinois. It extends almost due north and south and may be viewed in its entirety from the east. The view from the west is partially obstructed by trees and underbrush.

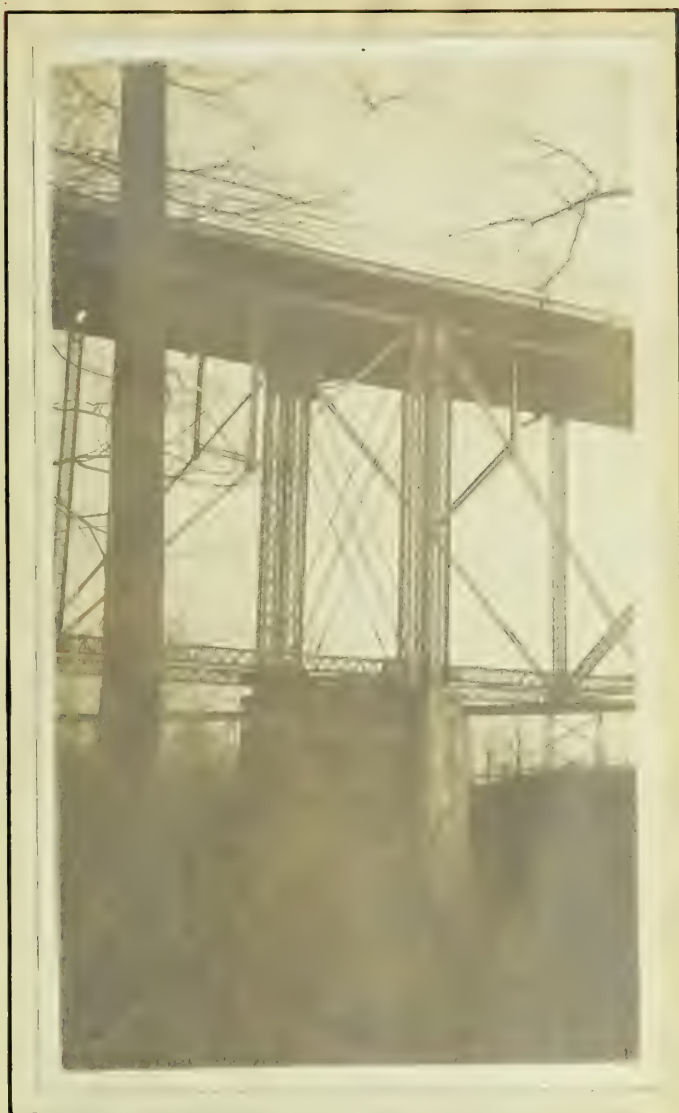
CENTRAL PIER

Piers The two river spans are supported by three piers, two of which are built up approximately by twenty feet above the surface of the ground. The third, which supports the south end of the south span is just level with the ground. The two former piers are made up of pitch faced ashlar masonry, the blocks of stone varying from  $2' \times 4' \times 1\frac{1}{2}'$  to  $1' \times 2' \times 1'$ . The central pier (see photograph) is considerably skewed, being at an angle of about

65°, instead of 90°, with the axis of the bridge. This pier is 25' x 4' on top and has a batter of about 1 to 10 on two sides.

All piers are satisfactory. Pressure area is sufficient. Joints are well preserved. Some of the blocks in the skewed pier are burrowed into, but not to such an extent as would be harmful.

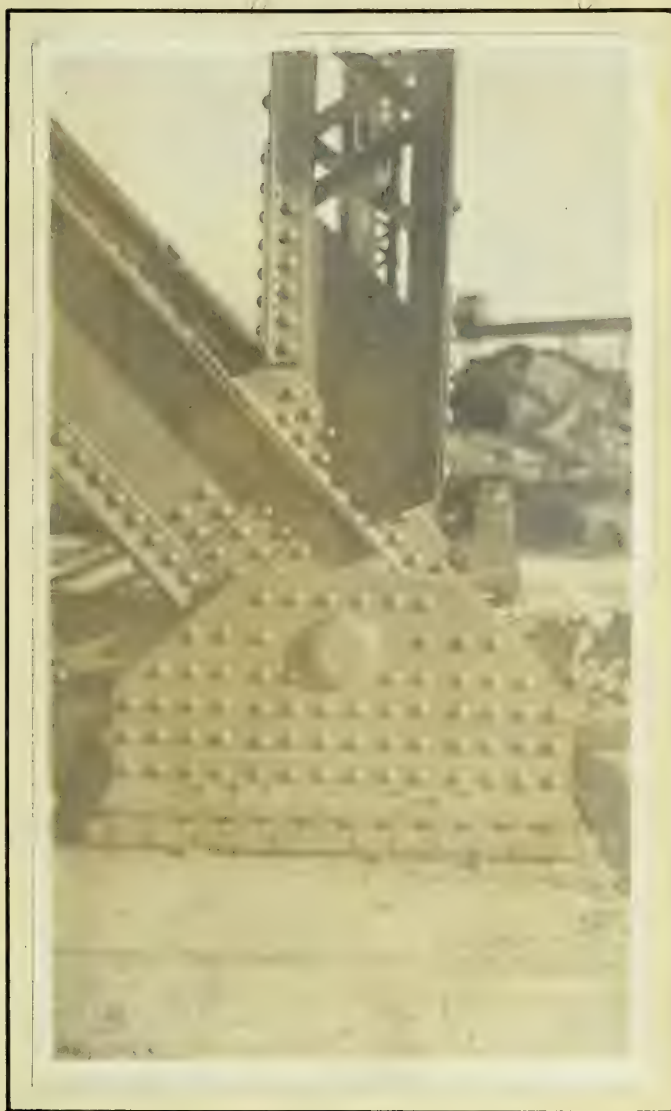
EXPANSION JOINT

expansion joints which are practically new. The rollers in each of these joints (12 in number) are 3 inches in diameter and 30 inches long. The old rollers, which are at present lying near the pier, apparently have never rolled since the erection of the bridge as they are clogged with dirt and rust in such a way as to appear like a solid mass.

The accompanying photograph gives an idea of the present expansion joint.

(See photograph on sheet 2) The south end of the truss rests upon a nest of 12 - 3" x 30" rollers. The efficiency is 76% in bearing. The rollers are not large enough for this size span as they should have a diameter of 5 1/4 inches. See spec. art 127.

The pedestals and expansion joints in the south "River Span" are new, having been replaced within the last year. Those in the north "five Span" should be replaced. The rollers should be inspected, and, if necessary cleaned, at least twice a year.

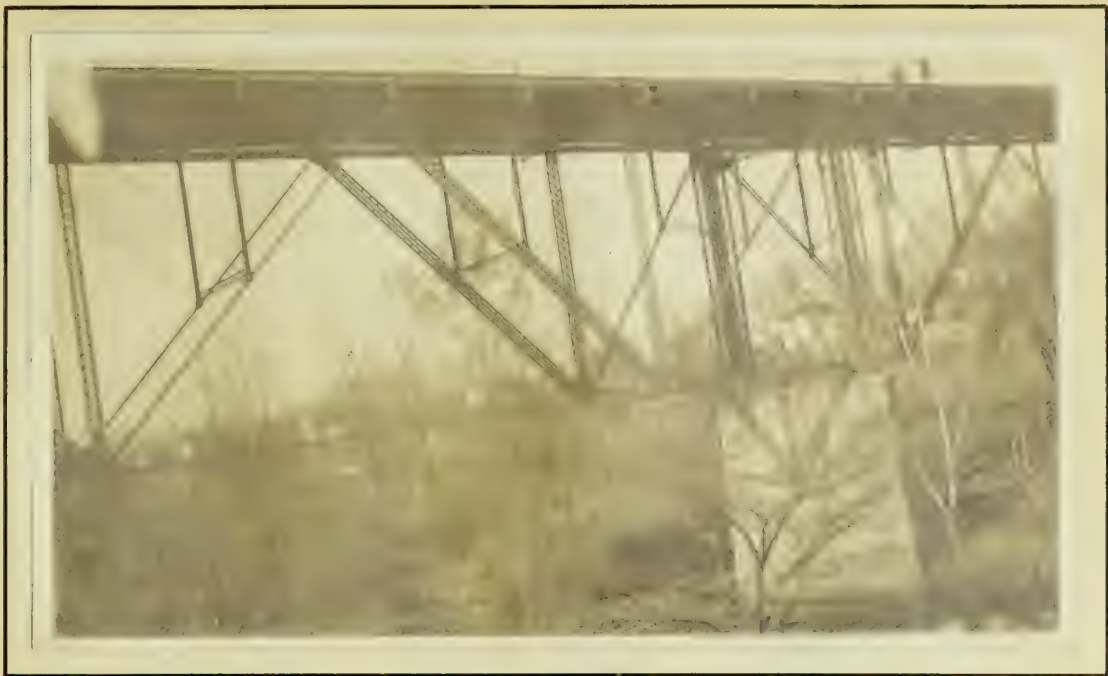
SKEW PANEL in WARREN TRUSS

1. Tension All eyebars are in good condition. They are well painted and the section has not been decreased by corrosion. No change is recommended.
2. Compression. The plates in the built up members are somewhat rusted on the inner face. As yet the corrosion is not sufficient to permit of its measurement. Such plates should have two coats of good quality iron ore paint, mixed with pure linseed oil. (See Art. 169)

The deformed lattice bars in member L, U<sub>3</sub> should be replaced by new ones. These

bars should be well painted as stated in Art. 169, (Spec)

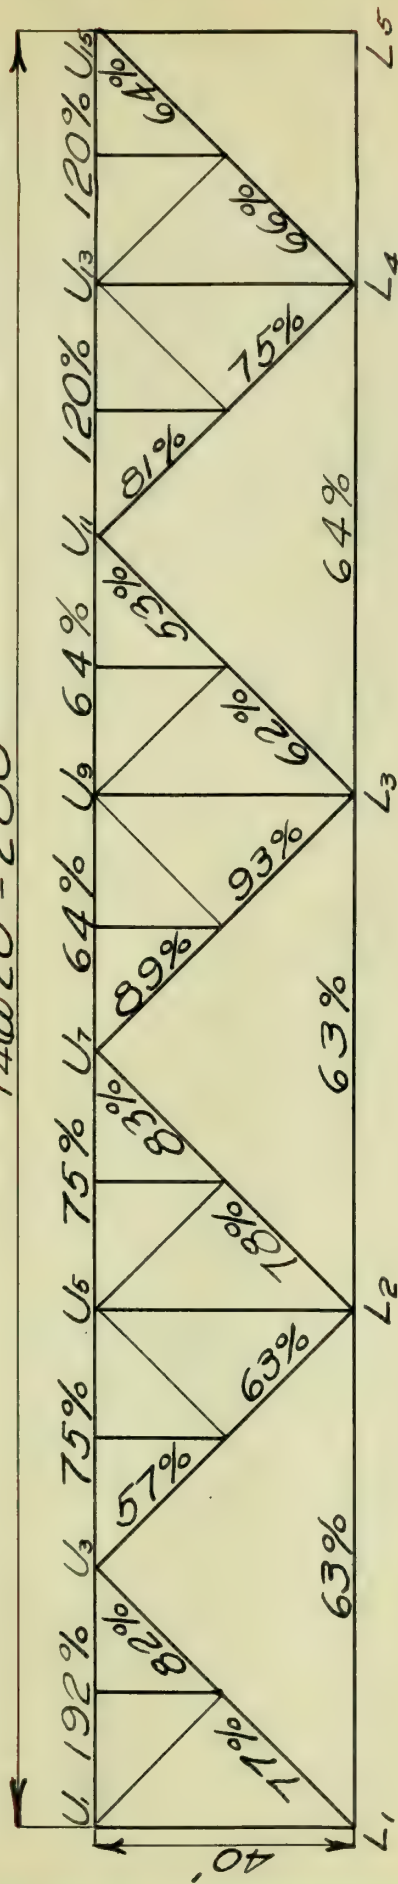
Fig. 1

Efficiency of Verticals = 78%  
 Efficiency of Sub Verticals = 103%  
 Efficiency of Sub Diagonals = 68%

Dead Panel Load = 20.0  
 Live Panel Load = 32.0

14 PANEL WARREN TRUSS

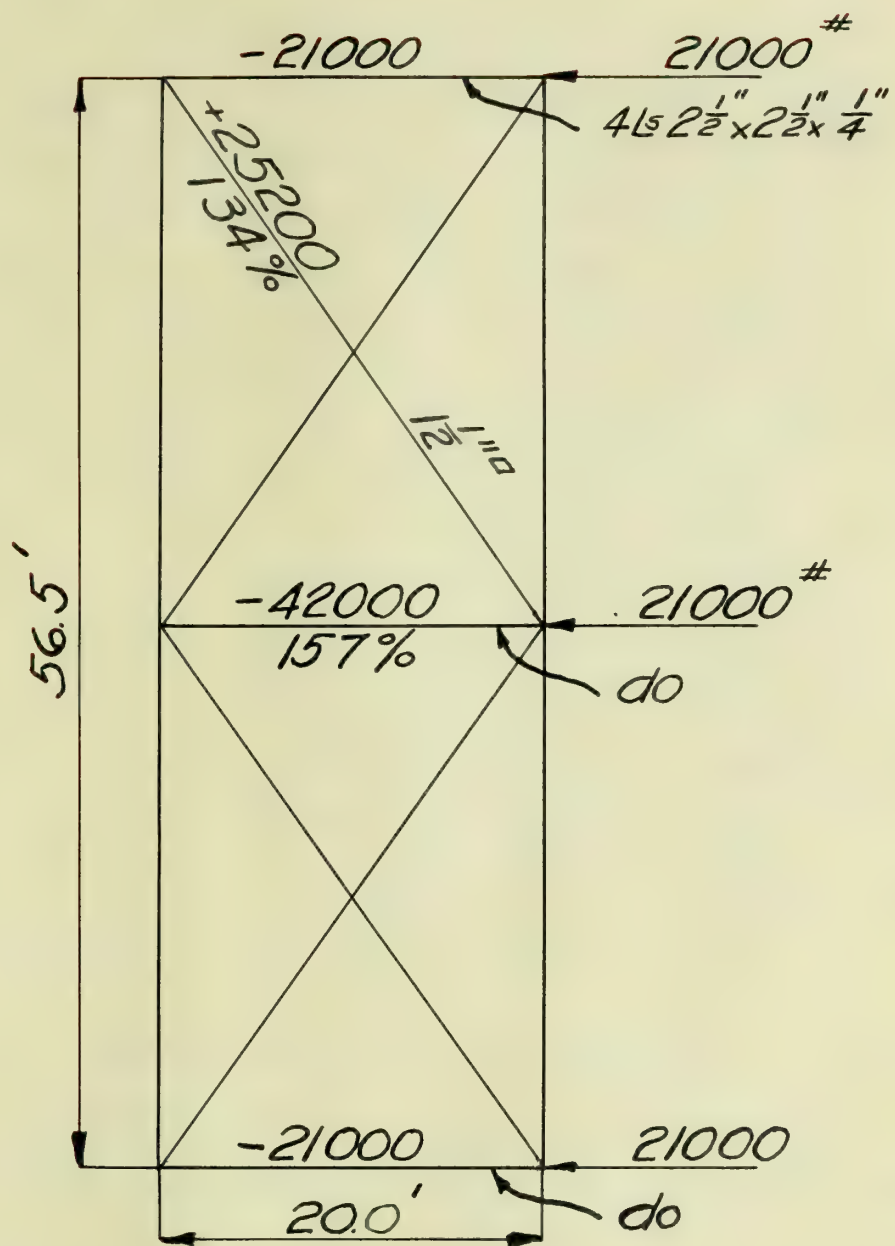
Fig 2

450<sup>#</sup> per linear foot of truss due to wind was assumed in computing the efficiencies in the end struts. (See Art. 37) These efficiencies are shown on Fig. 2, sheet 15.

In all the struts which brace the end web members, and which consist of 4 angles laced, there is a "trough angle." In every instance this angle is corroded to such an extent that it has practically no effective section. In the extreme cases, one might run his finger directly thru the angle. Such angles should be replaced by new ones of same section as that of the old. Strut connections seem to be in very good condition.

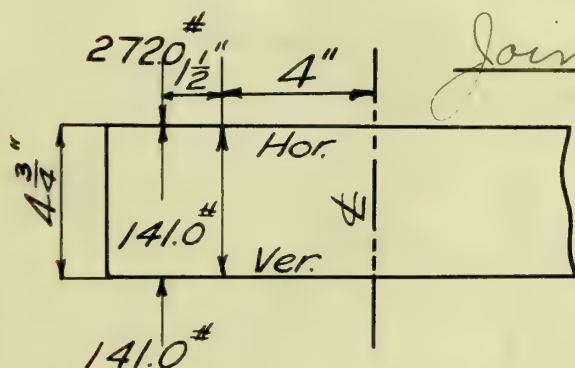
Joint at  $U_3$

Pin  $U_3$   
 Max. B. M. = 288000  
 Efficiency = 73%

46 Rivets used  
in built up web.  
Eff. (Shear) 81%  
Eff. (Bearing) 124%  
Eff. (Bearing on  
Pin) 51%

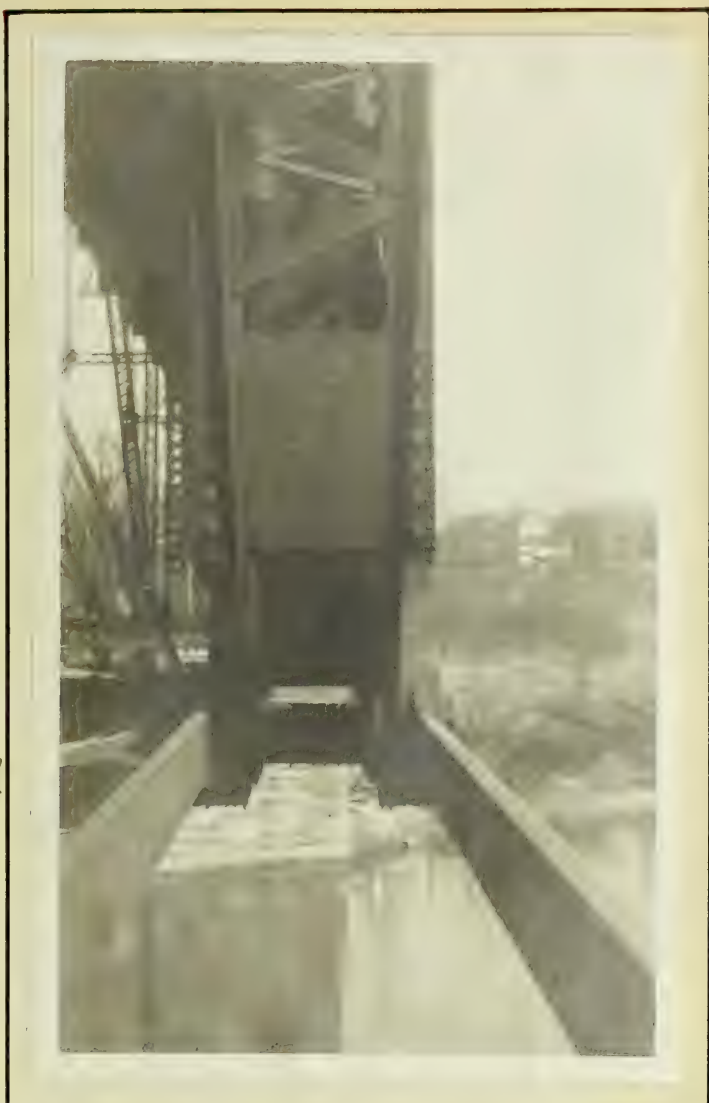
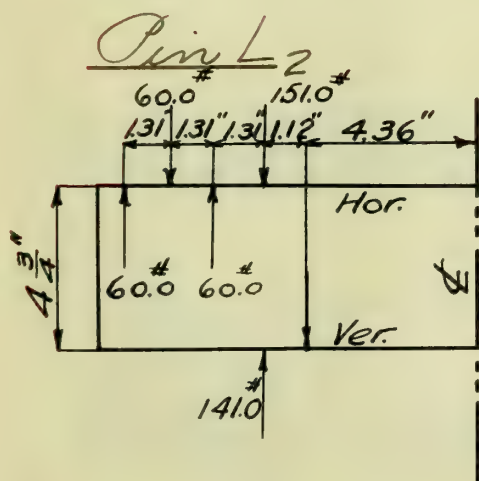
JOINT at  $L_2$

Riveting in  $L_2$   
28 Rivets used  
in built up web.  
Eff. (Shear) 81%  
Eff. (Bearing) 96%  
Eff. (Bearing on  
Pin) 50%

Max. B.M. = 184,000<sup>##</sup>  
Efficiency = 114%

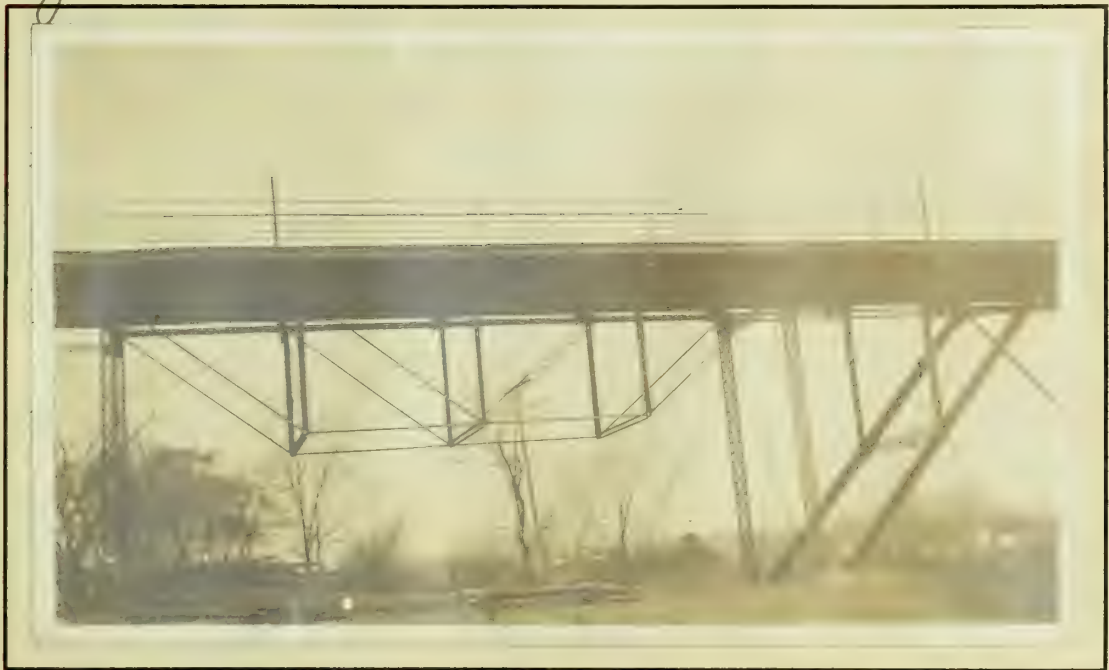
FOUR-PANEL PRATT TRUSS

The live loading for the 80 foot Pratt truss was secured from Table A in the specifications, as was that of the Warren truss. The dead panel load was considered as 18000<sup>#</sup>, the total weight of truss and one half of floor system being 71000<sup>#</sup>. For separate weights see Table C sheet 20. Stresses for each member along with its section may be found in Table D sheet 20. The efficiencies are placed upon the separate members in Figure 3 sheet 21.

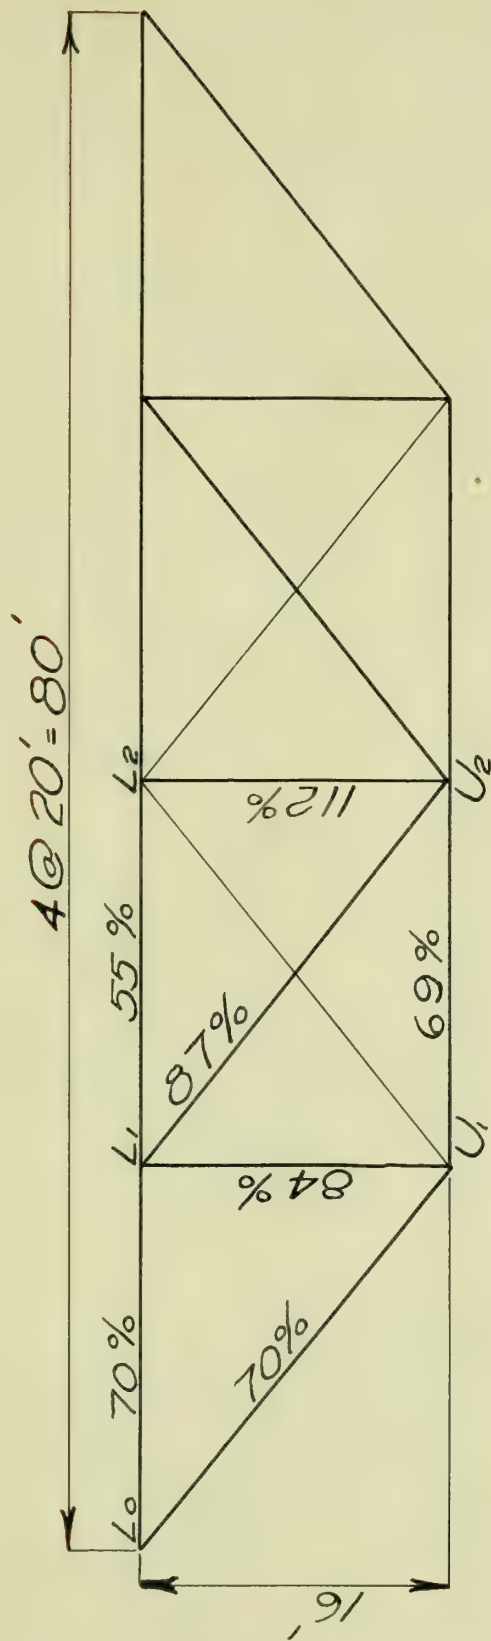
Fig. 3

Dead Panel Load = 18.0  
 Live Panel Load = 36.0  
 4-PANEL PRATT TRUSS

1. Tension. Physical condition is good. No change is recommended.
2. Compression. Upper Chord

in second panel should be increased by 40% of its own section, to bring its efficiency up to the average. This section may be increased by riveting reinforcing plates to the web of the Channel.

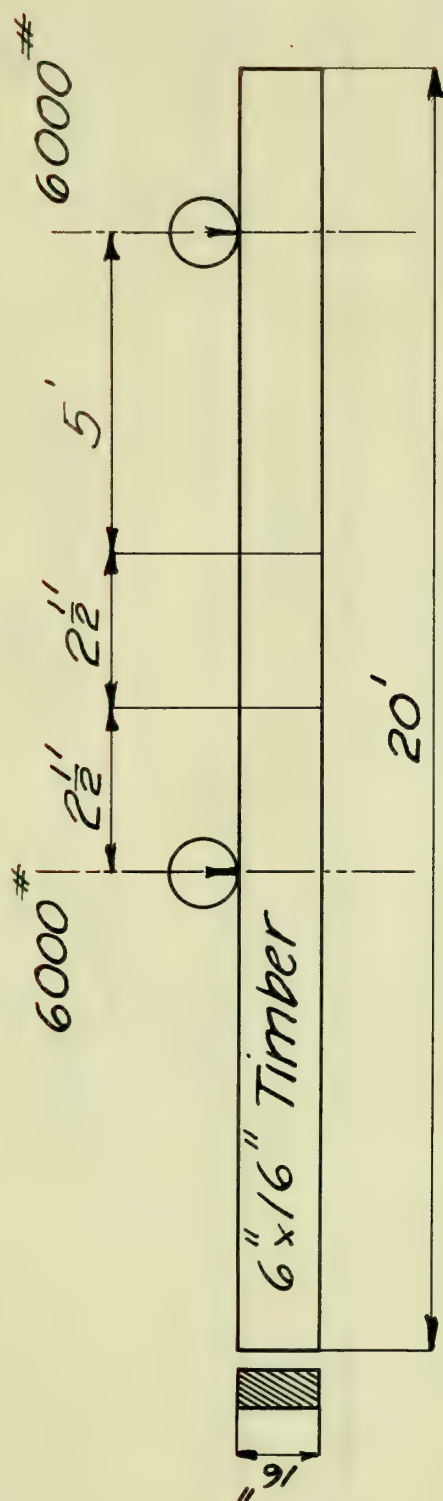
Fig. 4

The dead load bending moment at the critical section is  $46,000''^{\#}$  and the maximum live load bending moment is  $405,000''^{\#}$  making a total of  $451,000''^{\#}$ . The arrangement of loading and the efficiency of joist is shown on Figure 4, sheet 23.

Wheel Load = 12000#  
 Load on Joist = 6000#  
 Efficiency = 68%

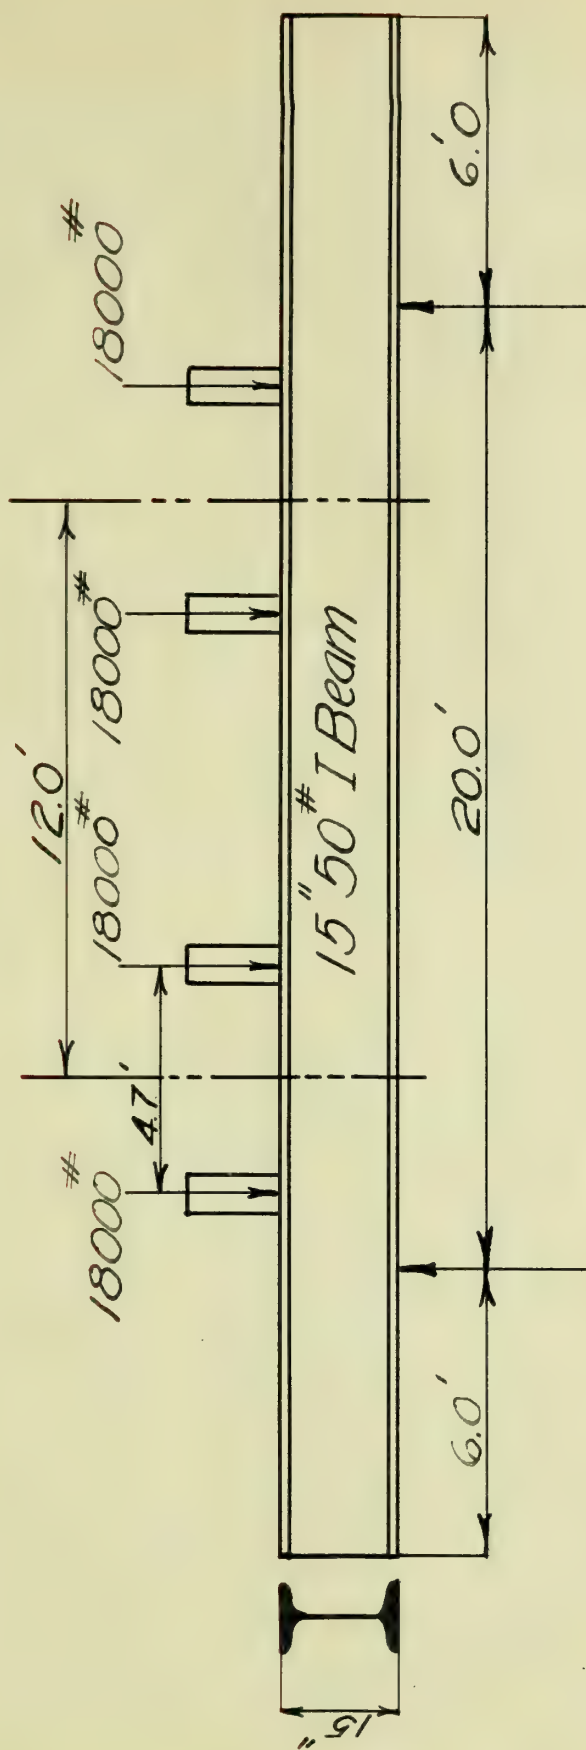
Fig. 5

The maximum bending moment in the beam is  $224,400''^{\#}$ . The arrangement of loading and the efficiency of I beam is shown on Figure 5 sheet 24.

Concentrated  
Wheel Load = 18 000 #  
Efficiency = 37%

Uniform  
Uniform Load = 2000 # per ft  
Efficiency = 55%

Because of their extremely low efficiency, it is recommended that these 15"-50<sup>#</sup> I beams be replaced by 15"-70<sup>#</sup> I beams

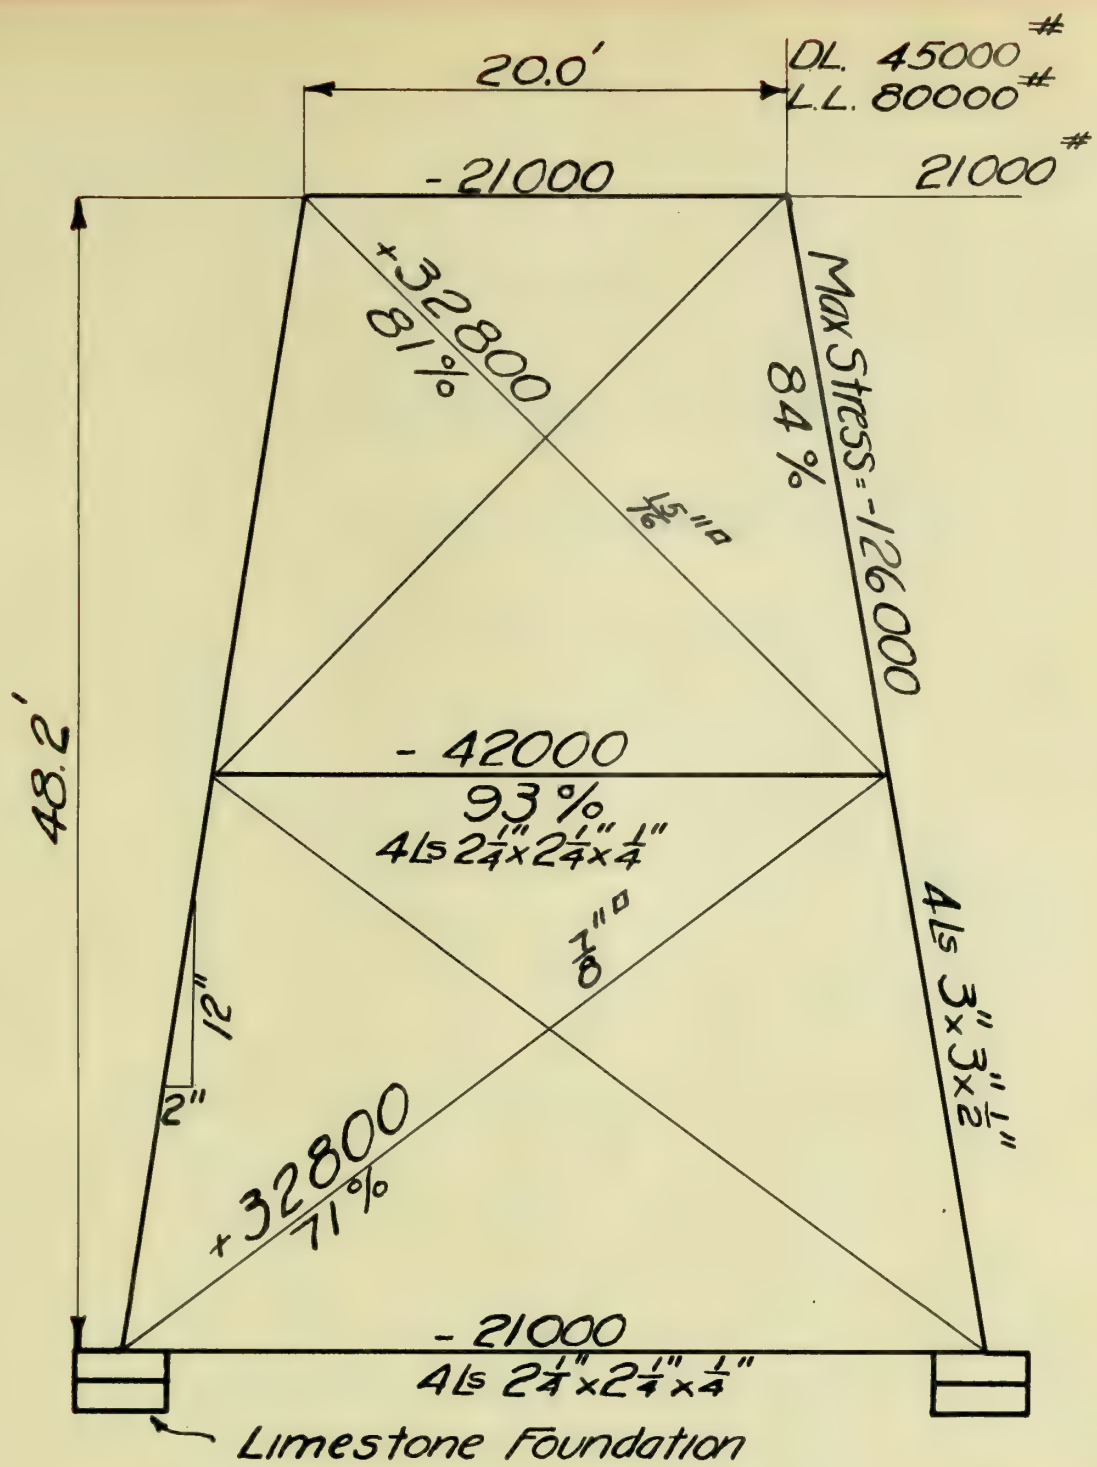
Fig 6

The total stress coming into each post of this bent is 126,000<sup>#</sup>, 45,400<sup>#</sup> being due to dead load reaction and 80,600<sup>#</sup> due to live load reaction. The wind load stress is 25,100 which is less than 30% of sum of live and dead load stresses. Therefore it is not considered in the efficiency.

For stresses and efficiencies see Figure 6 sheet 26.

Lower braces are considerably rusted. They also do not seem rigid enough, considering their length. It is recommended that they be replaced by members which consist of 4 angles  $2\frac{1}{2}" \times 2\frac{1}{2}" \times \frac{3}{8}"$  laced.
